X-ray Computed Tomography for failure analysis in on-board electronics

Technocentre Renault, Guyancourt, France

Cécile Plouzeau – RSA Renault Group
Jean Baptiste Blumenfeld – RSA Renault Group
Roland Le Floc'h – RX Solutions

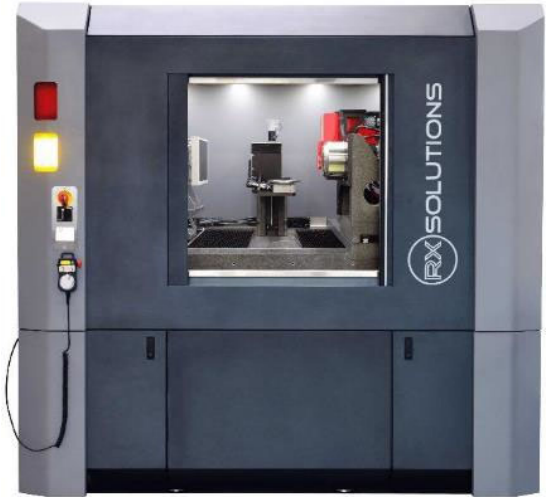
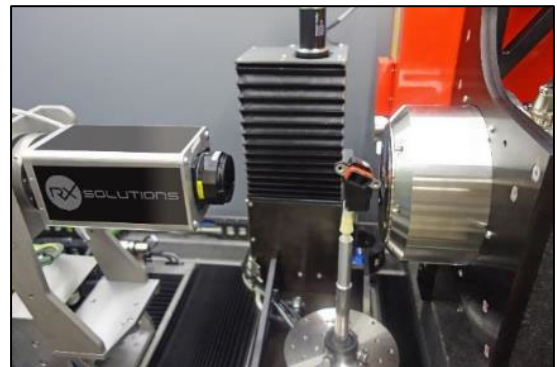
RX Solutions EasyTom 160 Multi-Purpose NanoTomograph

Equipped with a nano-focus tube and a micro-focus tube, a large flat panel detector, and a high-resolution X-ray camera, coupled with advanced acquisition modes such as local multi-scale scans, limited angle acquisitions, the EasyTom 160 nano-tomograph offers the flexibility to perform high-resolution tomography scans regardless of the component's size and geometry.

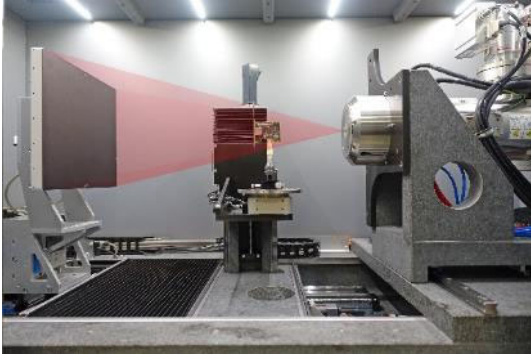
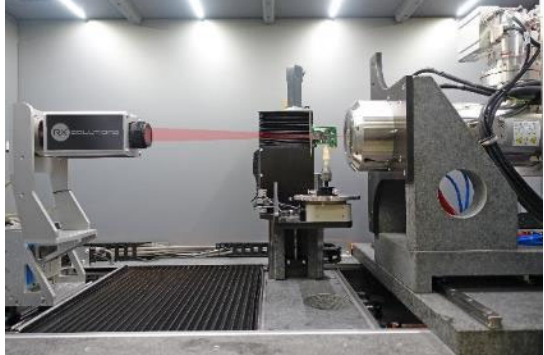
Global scan configuration scheme seen from above and very high resolution local scan configuration

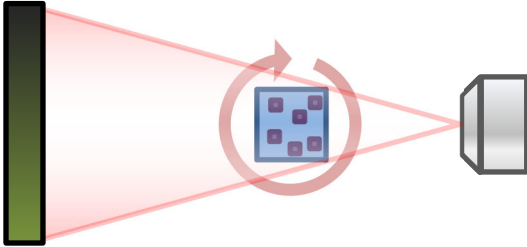
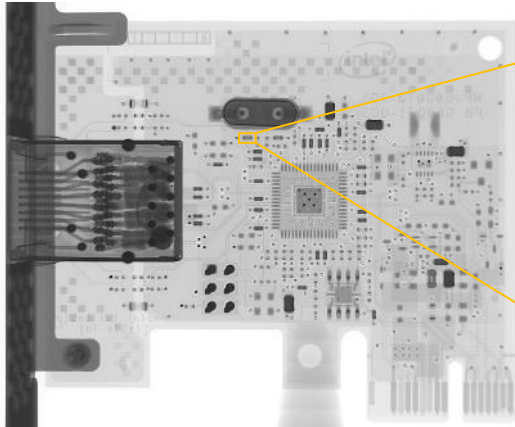
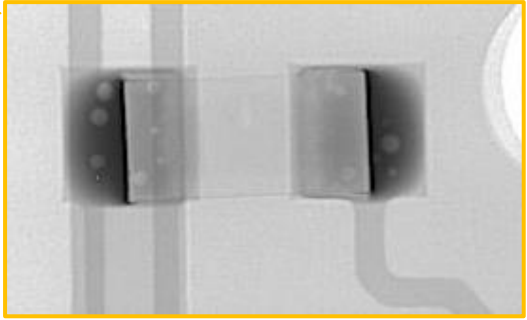
<p>Global scan of the complete part to locate the defects.</p>

<p>Very high resolution local scan focused on one single component.</p>
Field of view in global scan configuration and in very high resolution local scan configuration

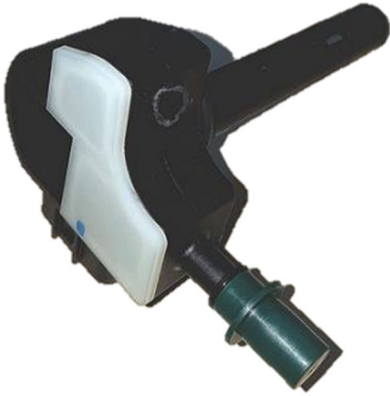
Case n°1: Water sensor - cracked diodes

The sensor is made of a card encapsulated in black resin.
The part is inspected as a whole: dimensions 100x80x60mm

Failure: Sensor not working.

Root cause: Mechanical breakage of the diode glass due to mechanical stress.

Hypothesis: The mechanical stresses induced by the resin (during its polymerization for example) may have put the PCB in slight bending due to its design, which caused the breakage of the 2 diodes located in the area most sensitive to this bending.

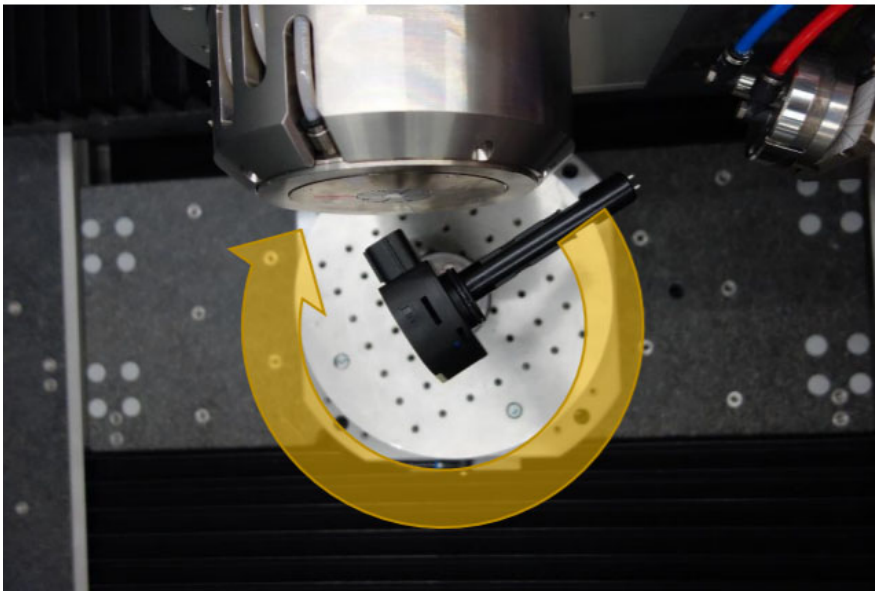
Positioning of the sensor in the tomography system:

Limited angle acquisition
allowing to obtain a strong
magnification despite the 10 cm
long branch.

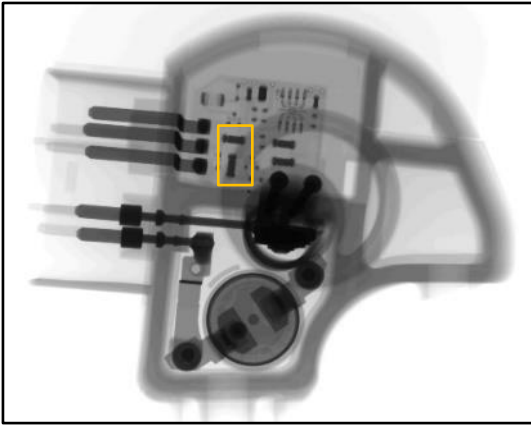
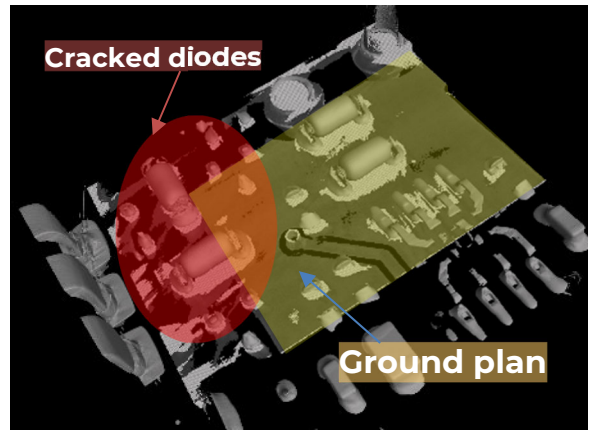
Location of the incriminated diodes in the water detector.

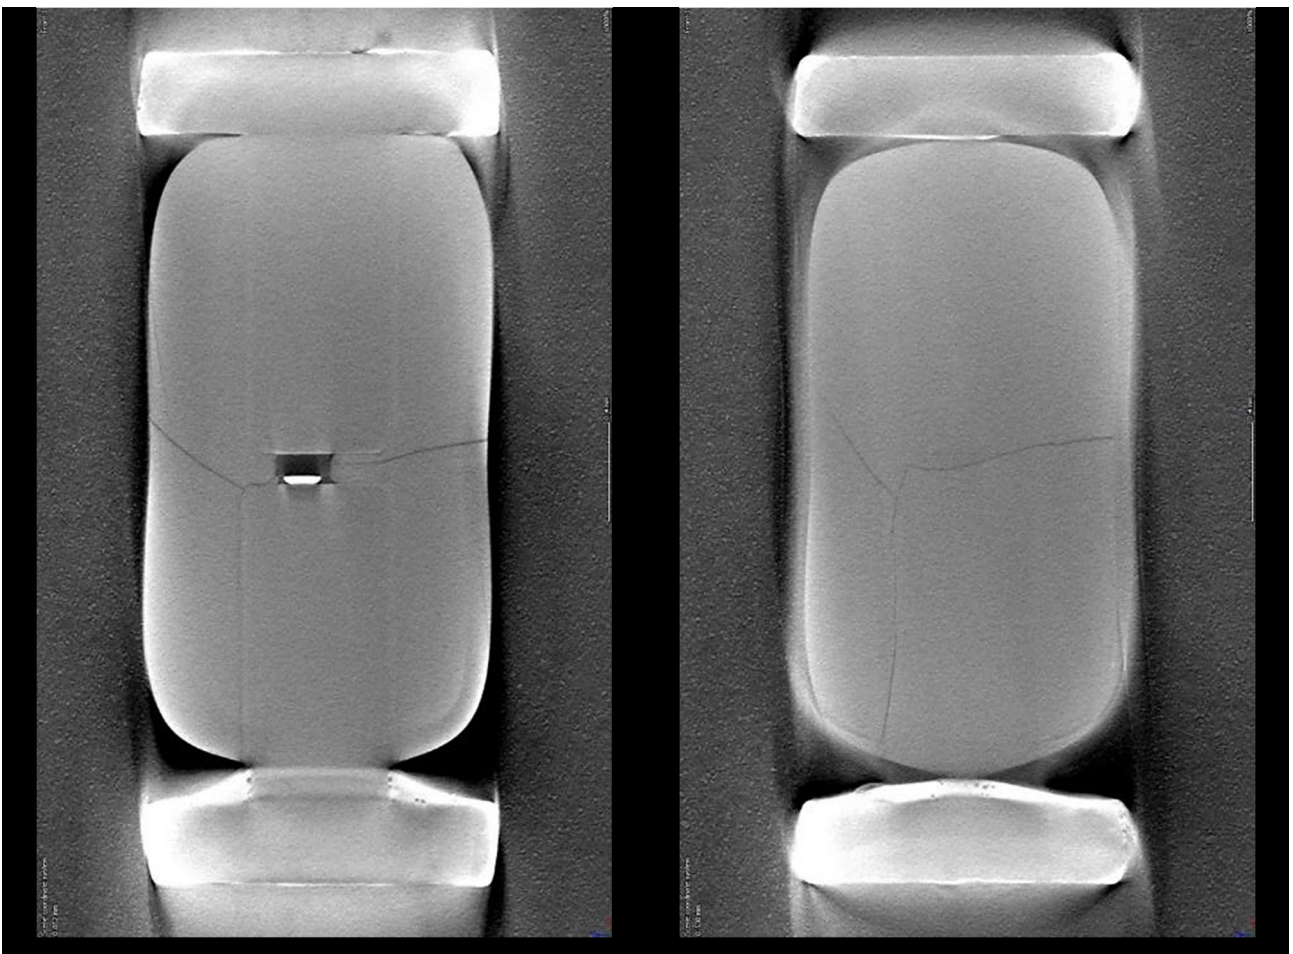
EasyTom 160 -Voxel size: 2 μ m - Whole part acquisition 100x80x60 mm

Cracking of the diode glass

“The high-resolution CT scans were able to unambiguously show the cracks in the glass. A mechanical cutting approach would have been inconclusive because the cuts could have potentially created these cracks in the brittle glass. The cracks are a few microns in size.”

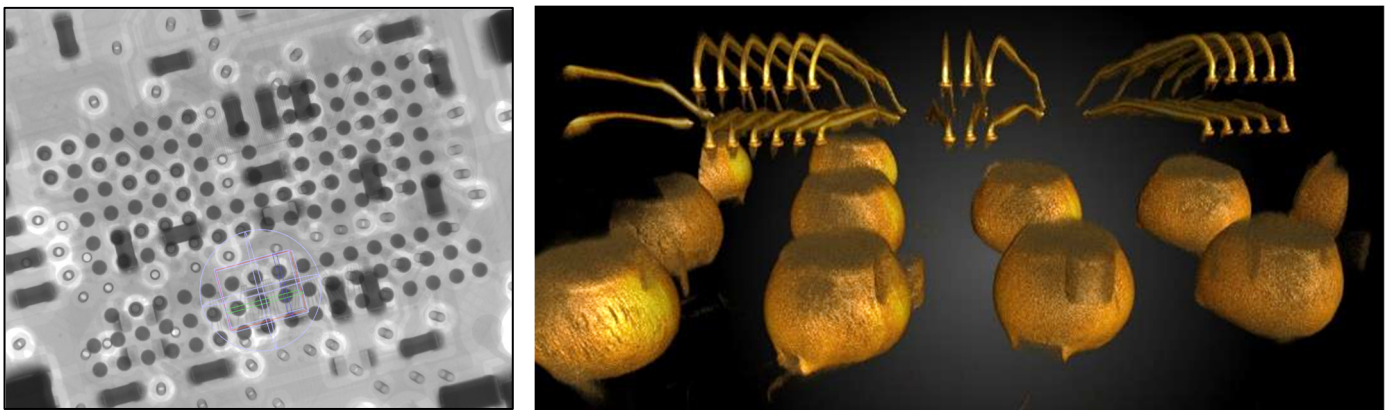
Visualization of the components of the electronic board by 2D radiography and 3D rendering by tomography.

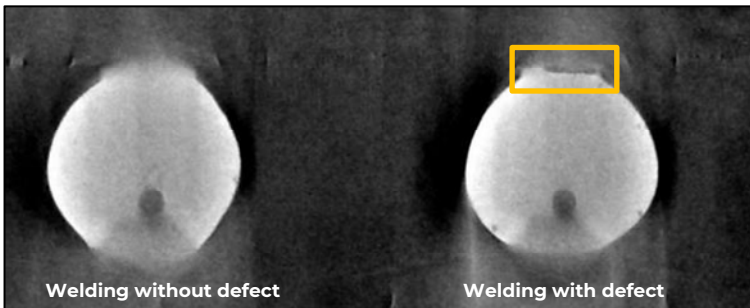
Slice A-A

Root cause: A crack was highlighted on a log. Tomographic sections were used to locate the faulty log and identify it: it is log N°7 on row 2. Subsequently, polished sections were made, with the aim of polishing in the line N°2 to be appraised. The optical microscopy of the ball N°7 confirms the damage highlighted by the high resolution tomography. It is a delamination of the brazing ball on the component side, subjected to expansion stresses at high temperature during the brazing process.

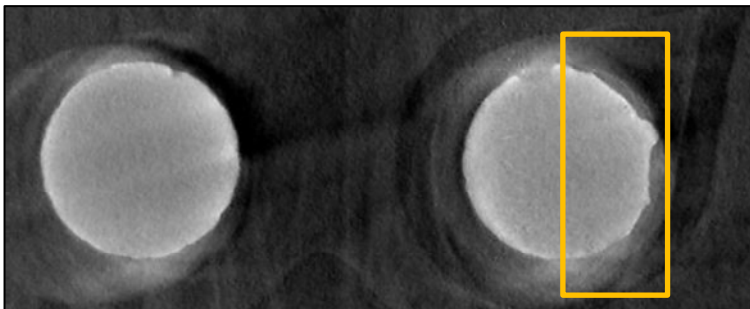
Slice B-B

1. 3D tomographic slices of BGA balls with and without defects. Localized cracks in the red box...

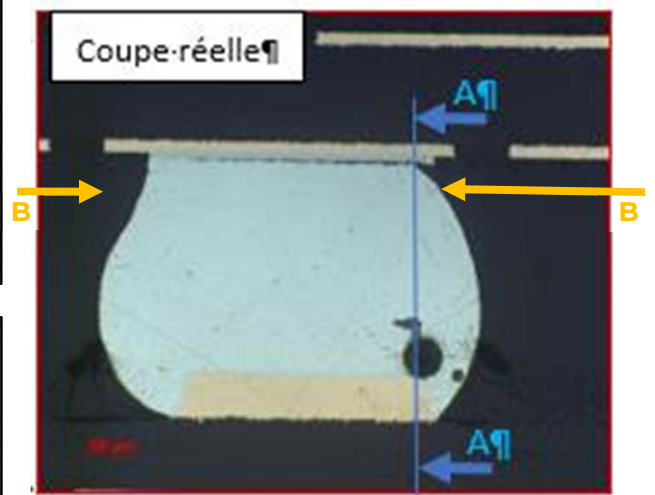
2. The actual cut confirms the presence of a crack in the BGA weld.

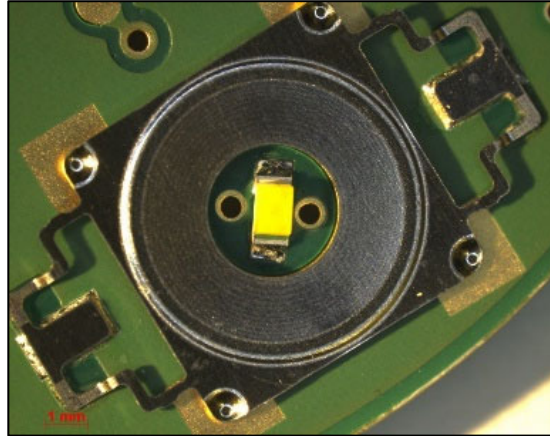
Individual analysis of the micro-switches present on the card, inside the box

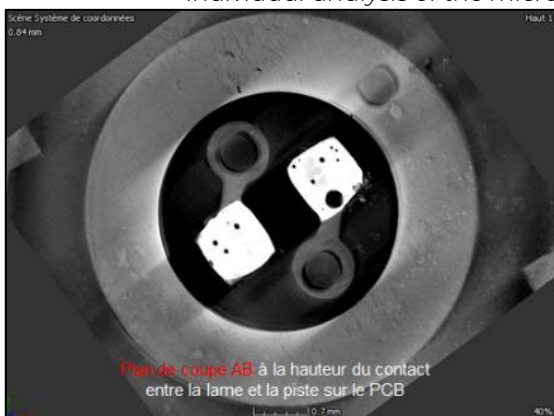
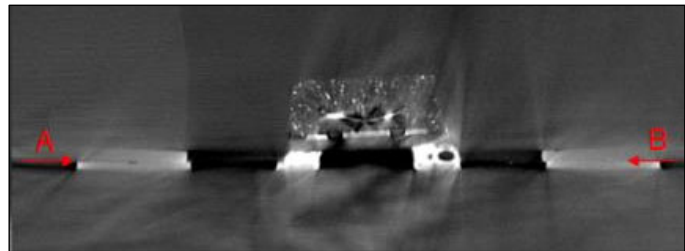
Root cause: Pollution by corrosion products at the blister/PCB interface: Contact impossible

EasyTom 160 - Voxel size : 4µm - Acquisition on whole part (40x30x10mm)
Pollution by corrosion products at the blister/PCB interface : Contact impossible

The opening afterward makes it possible to confirm the presence of pollution and identify it

“At the level of the failed micro-switch, high-resolution tomography revealed significant pollution on the PCB surface and at the Track/Clockers interface. Hence the relevance of performing the analysis without opening the part, which avoids the risk of the artifact.”

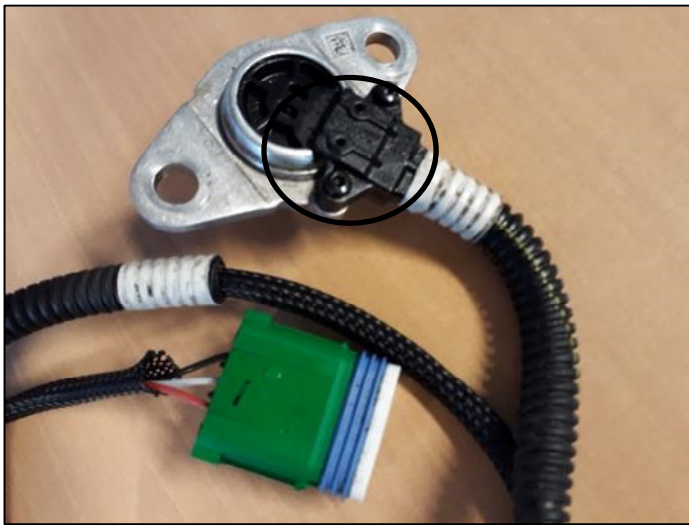
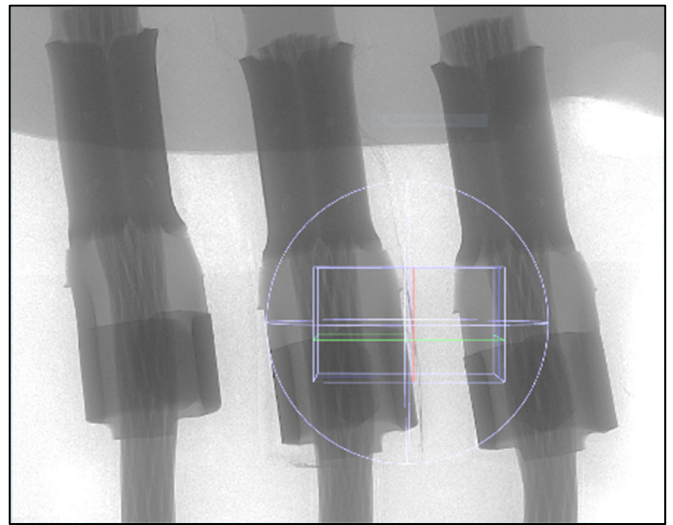
Full pressure sensor. High-resolution scan on an area between the crimps

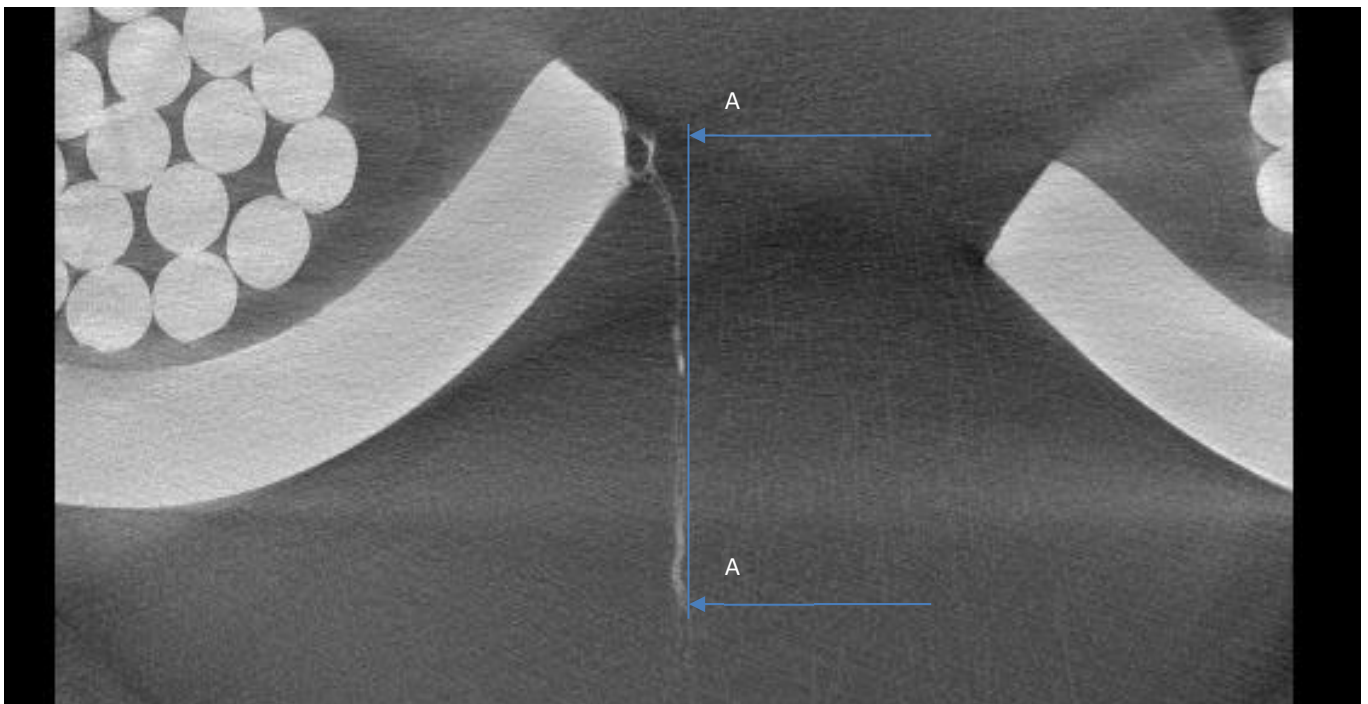
Sectional drawing A-A

Root cause: Water infiltration + salts at the interfaces between the overmoldings and the various metal elements. The power supply in the presence of salt water causes corrosion and migration of metallic salts between the different tracks, along the free interfaces between the different overmolds. This creates conductive bridges forming dendrites with characteristic ionic migration facies, which are sources of leakage or short-circuit current.

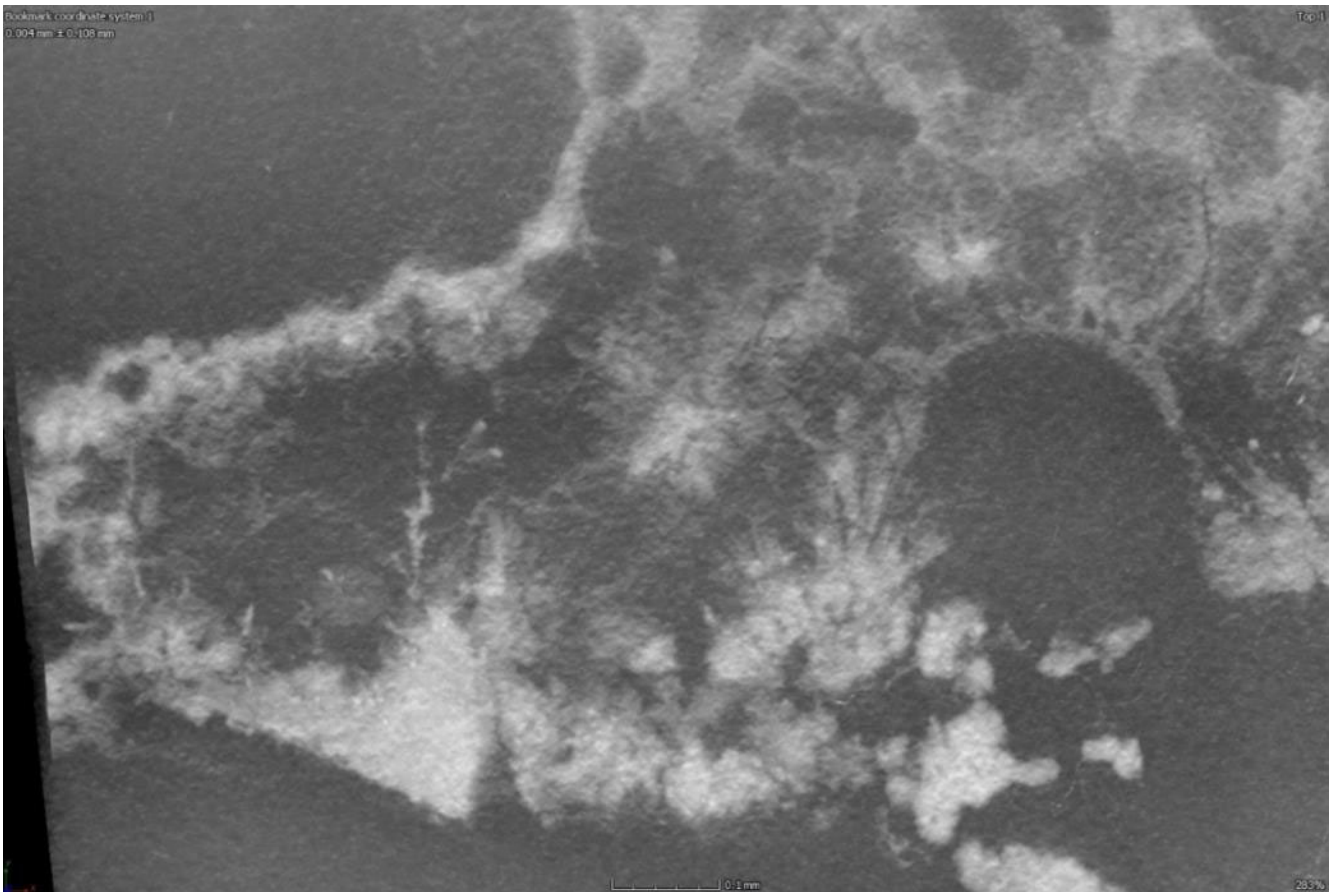
*AA virtual sections: observation of characteristic dendrites
easy to 160 -Voxel size: 4 μ m - Acquisition on whole part (5x5cm)
The internal ion migration between the crimps leads to the formation of dendrites*

“Opening such parts is not possible without destroying the dendrites. The high-resolution tomography allowed to highlight these dendrites undoubtedly, whereas the electrical tests were not discriminating (too dependent on the measurement conditions).”
